**Re: Request for Approval of TSCA Self-Implementing Clean-up Plan of PCBs
Hangar 14
Newark Liberty International Airport
Newark, Essex County, New Jersey**

REQUEST FOR APPROVAL OF TSCA SELF-IMPLEMENTING CLEAN-UP OF PCBs

Hangar 14

**Hangar 14
Newark Liberty International Airport
Newark, Essex County, NJ**

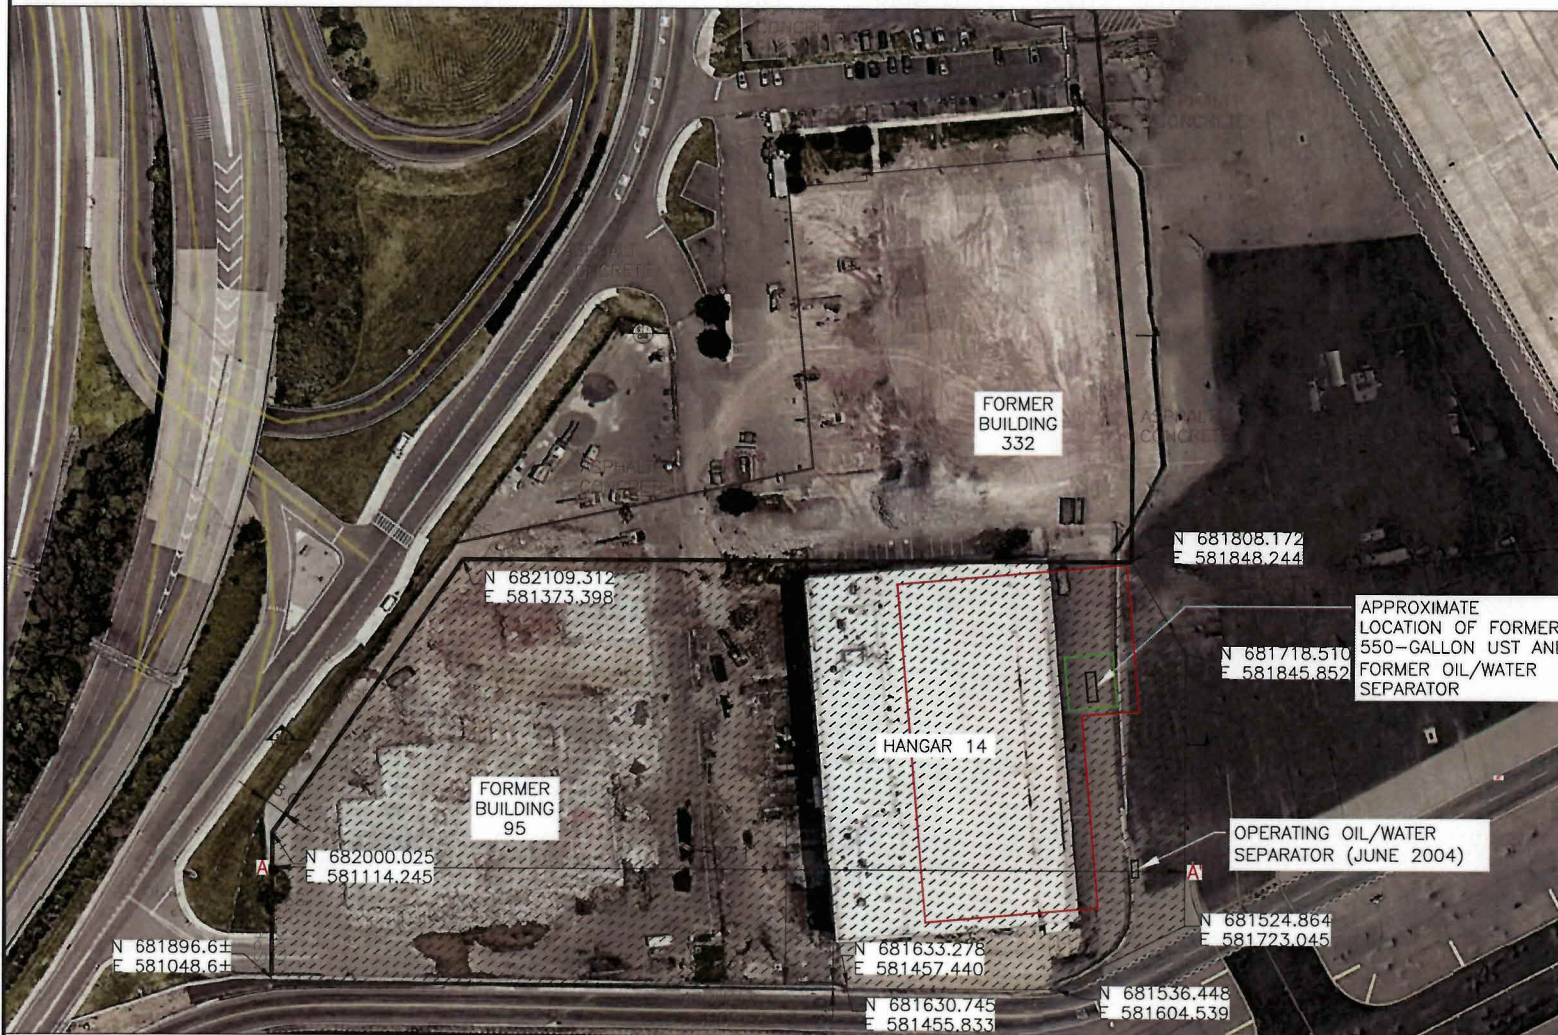
of
Worksheet Number
490011696
Drawing Number
FIGURE_4

should be noted that the cap is part of construction for the Overnight Aircraft Parking Area that, as shown on **Figure 4**, will cover a much larger area than the Deed Notice.

AREA SUBJECT TO ENGINEERING CONTROL WITH DEED NOTICE FOR HIGH OCCUPANCY USE EXCEPT LOW OCCUPANCY SECTOR AS NOTED

because Newark International Airport is a federal elevated security area, the Site is surrounded by a security fence to prevent unauthorized access. **Figure 4** shows the location of the engineering control and **Figure 5** illustrates the construction details of the engineering control. Included in **Appendix D** is a copy of the Asphalt Concrete Paving Section (Section 02553) of the Construction Specifications for the Overnight Aircraft Parking Area. Please refer to the table on page 29 of the specifications that defines the compositions of both asphaltic concrete and of plant mix macadam.
